# Rapid diagnosis of low hanging fruits in low-carbon energy investment

Edition:  
September 2024

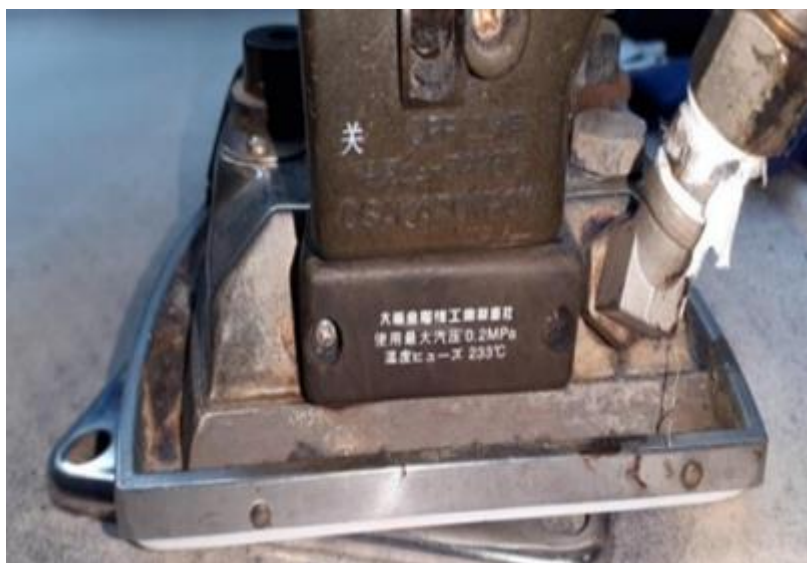
**Issue:** During the energy audit, several crucial observations were made regarding the factory's energy infrastructure. The factory utilizes wood-fired boilers for steam generation, and it was observed that the exhaust flue gases had elevated O<sub>2</sub> levels, causing significant heat loss and reduced boiler efficiency. Additionally, uninsulated pipelines in the steam distribution system were identified, contributing to heat loss. The factory also utilizes electric steam boilers for ironing, and the study revealed that these boilers frequently operate at higher pressures than necessary, resulting in inefficiencies and energy waste.

Ironing machine designed for 0.2MPa

**Intervention:** It was recommended for factories to install an O<sub>2</sub> monitoring system in boilers, install a float-level switch, and optimise boiler pressure as needed.

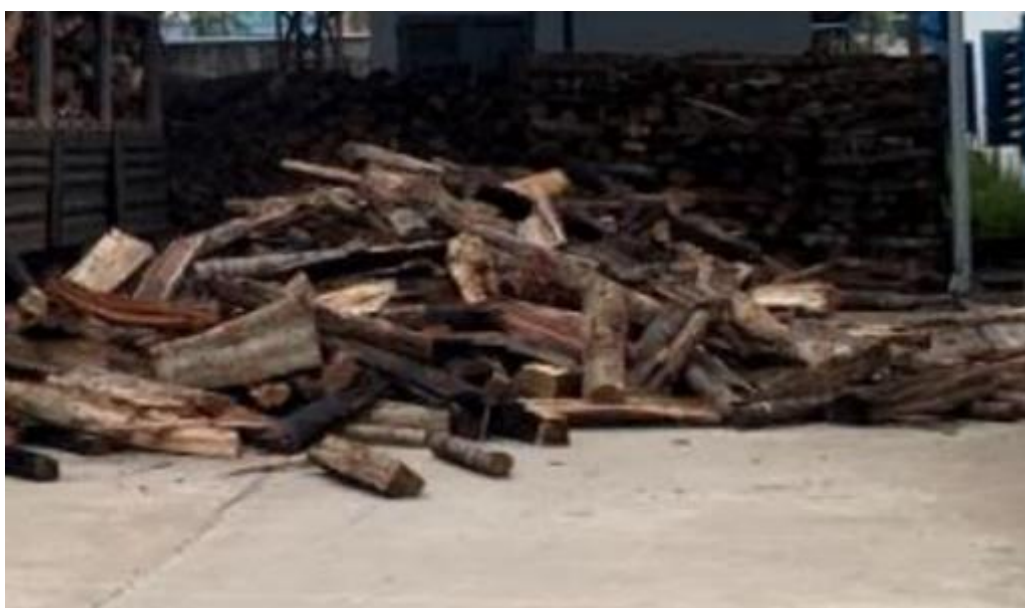
**Issues:** Presently, the factory utilizes large forest wood logs as a fuel source for its boiler. This choice of fuel presents certain challenges, primarily linked to incomplete combustion, which is signified by elevated carbon monoxide (CO) levels and higher oxygen (O<sub>2</sub>) levels. The use of larger wood logs leads to an inefficient air-fuel mix, resulting in incomplete fuel combustion within the boiler. It is crucial to understand that this incomplete combustion not only impacts boiler efficiency but also poses potential health hazards for the employees working in the boiler section. Hence, exploring alternative, more efficient fuel sources for the factory's heating needs becomes a primary objective.

Firewood logs

**Intervention:** It was recommended that small wood logs (maximum size 30 to 50 mm), be used for better combustion and to reduce heat loss due to incomplete combustion.

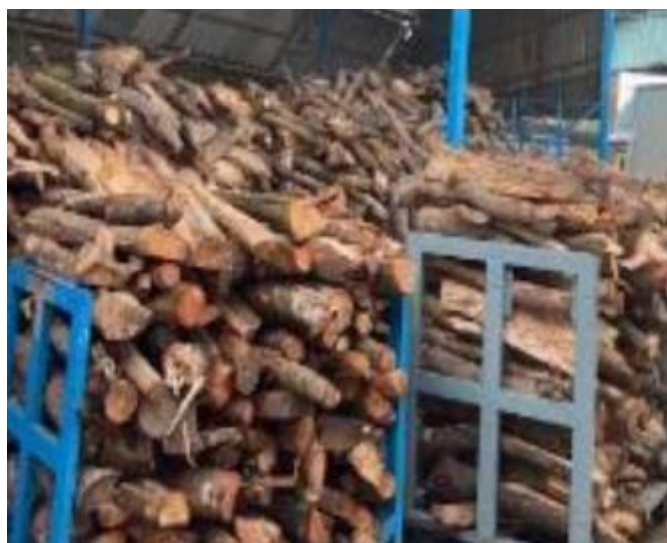
#### Firewood

**Intervention:** To mitigate these concerns, it is imperative to ensure that wood fuel is adequately seasoned and dried to the appropriate moisture content (moisture < 20%). Implementing moisture control systems, adhering to best practices in wood fuel storage and handling, and prioritizing combustion efficiency measures are essential for enhancing boiler performance, reducing emissions, and maintaining compliance with environmental regulations and air quality standards.

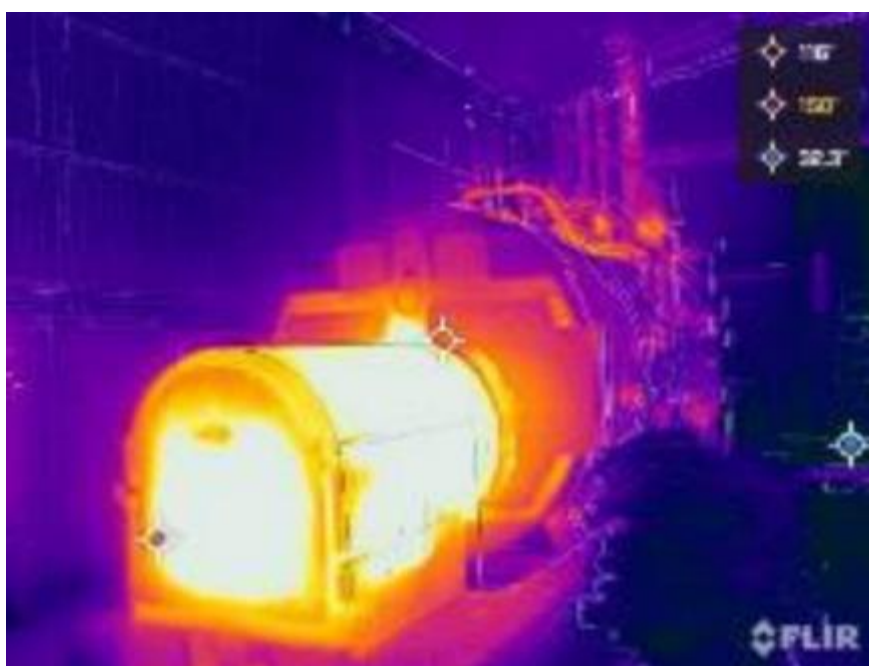
Temperature profile of boiler

**Intervention:** It's recommended to do the relining of the furnace, use a nano protective coating, and insulate the curing oven with an aluminium foil air bubble insulation sheet to reduce radiation losses and improve the working condition. And insulate the boiler during shut-down or maintenance periods either with glass wool or prefabricated insulation blocks.

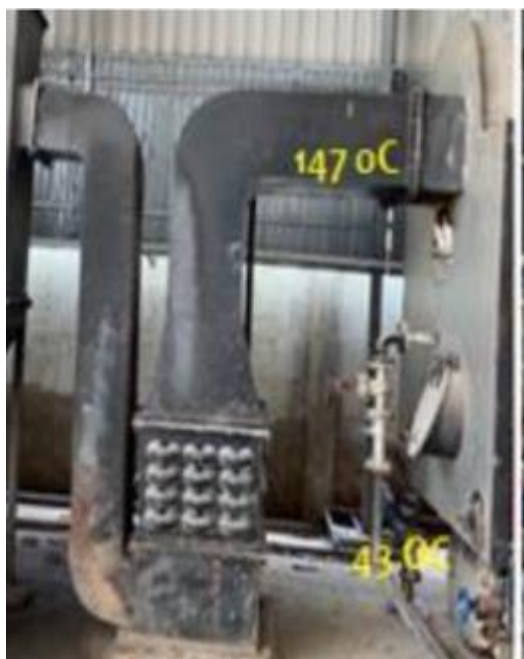
**Issues:** Uninsulated pipelines within a boiler system network led to a range of issues, including substantial heat loss, increased energy consumption, operational inefficiencies, a lack of temperature control, compromised reliability of heat and steam supply, and potential safety hazards for personnel working in the vicinity.

**Uninsulated fuel gas duct**

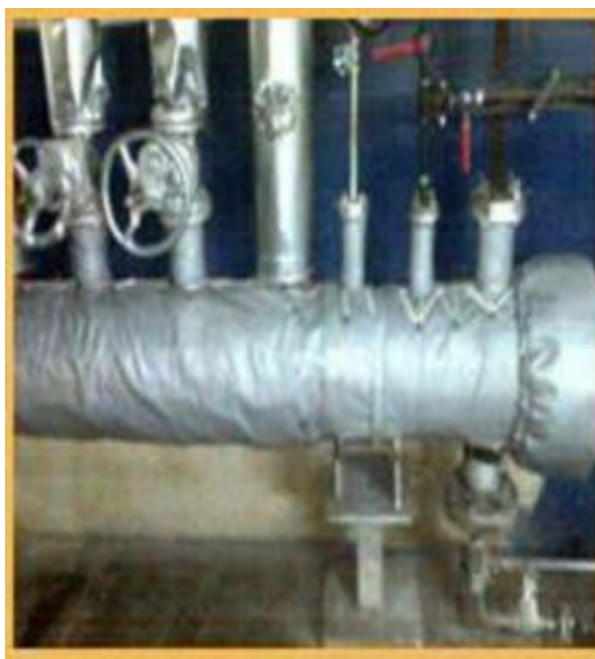
**Jacket insulation**

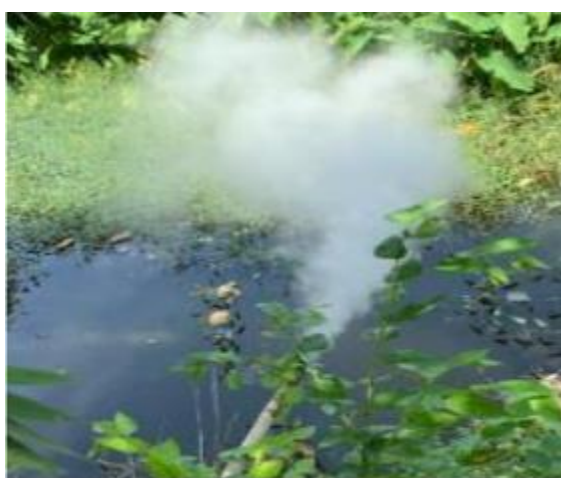
Condensate discharges out

**Intervention:** Installing a condensate recovery system is crucial not only for improving energy efficiency and reducing operational expenses but also for conserving water resources, reducing the environmental impact, and promoting responsible resource utilization, making it a key component in a sustainable and cost-effective boiler operation.

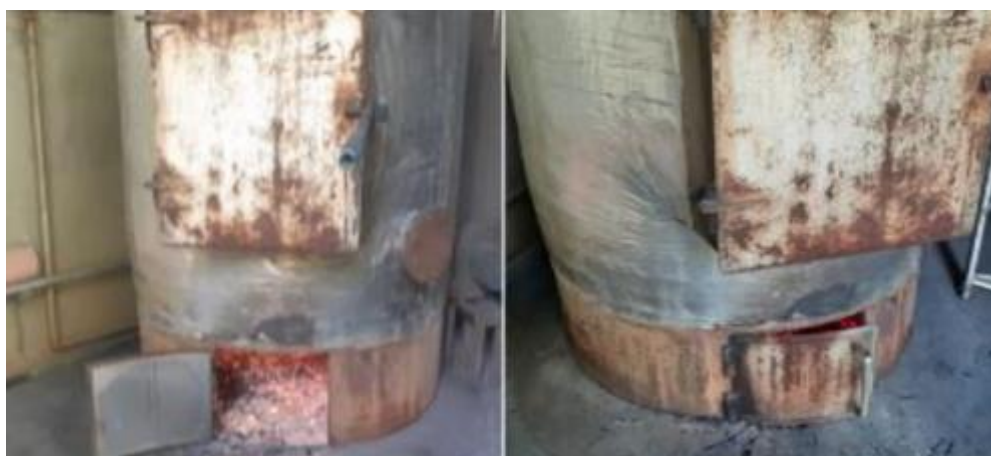
**Issues:** In the context of garment factories, common issues arise in the wood-fired steam boiler system. These issues include excess air leading to additional fuel consumption due to air infiltration through compromised doors and FD fans, often caused by broken locks and improper damper wane closure. Furthermore, while belt drives are installed to prevent stress on induced draft fans, discrepancies in the speed of the ID fan and the size of the connected motor's pulley have been observed.

**Present door position and suggested door position**

**Intervention:** It was suggested to install a VFD for the ID fan for precise control and flexibility. And install an inlet guide vane control (IGV) to regulate the air flow rate. The new IGV can be used for capacity regulation as per requirement, which minimises the present pressure drop. Additionally, the factory should install an Air Fuel Ratio Controller to enhance combustion control with various burner control boxes, allowing for multi-element control, fan speed monitoring, and oxygen trim for improved burner efficiency.

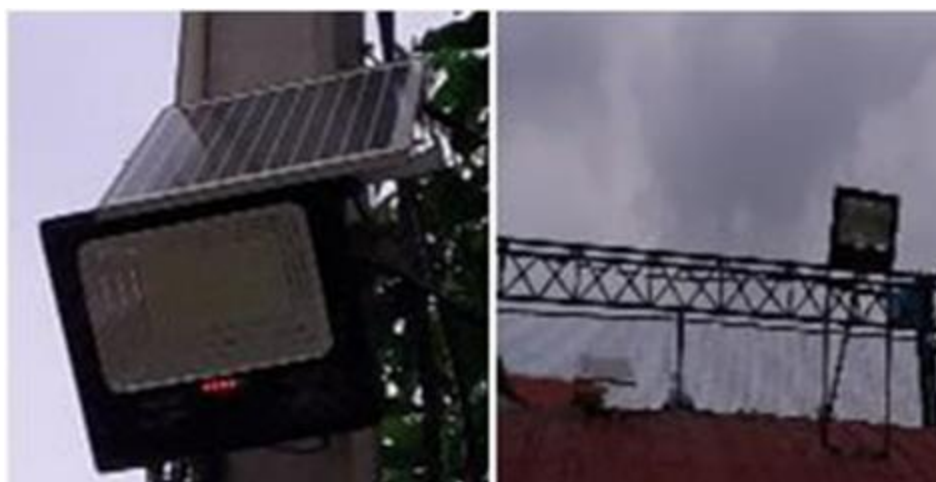
**Intervention:** Factories are encouraged to consider the implementation of solar lighting, especially for outdoor illumination, in order to enhance the contribution of renewable energy sources to the overall energy mix. This initiative not only reduces the reliance on artificial lighting and conventional electricity but also promotes sustainability and energy efficiency.

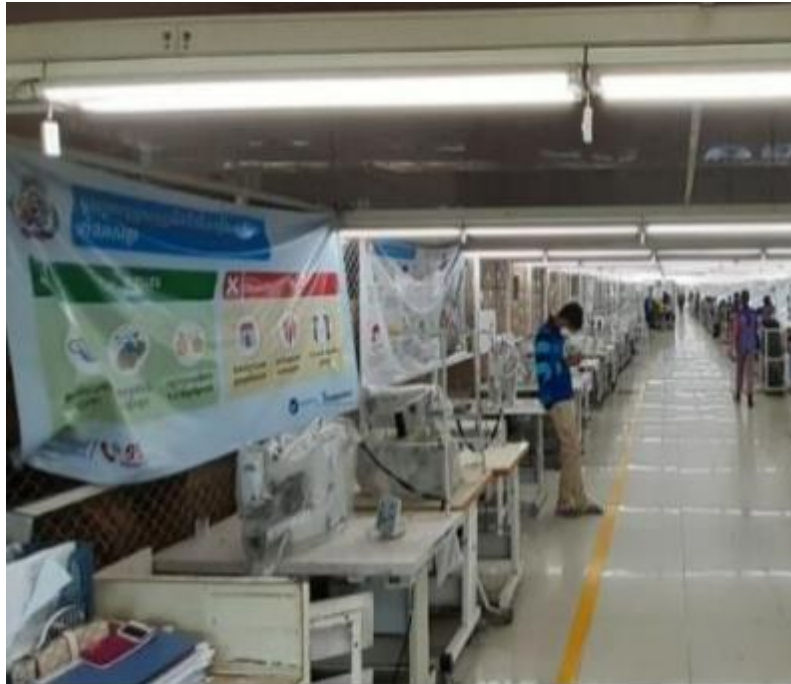
**Issues:** During the audit period, it was noted that a few areas of the factory can reduce illumination level: the area between the sewing lines and finishing section.

Proposed de-lamping area

**Intervention:** It is recommended for factories to switch off lights in non-operational areas where lighting can be reduced.

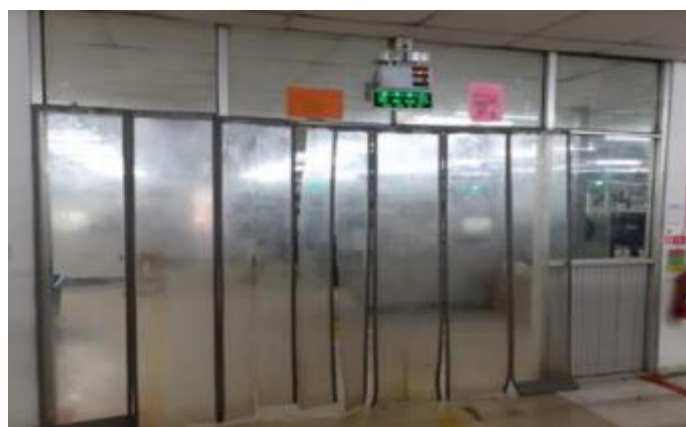
PVC strip curtain

**Intervention:** Recommendations include lowering the false ceiling height to 3.5 metres, installing thick PVC strip curtains at exit doors to enhance air cooler system performance and decrease energy consumption, and installing insulation for the roofing, specifically aluminium foil air bubble insulation, to enhance comfort, operational efficiency, and reduce cooling requirements.

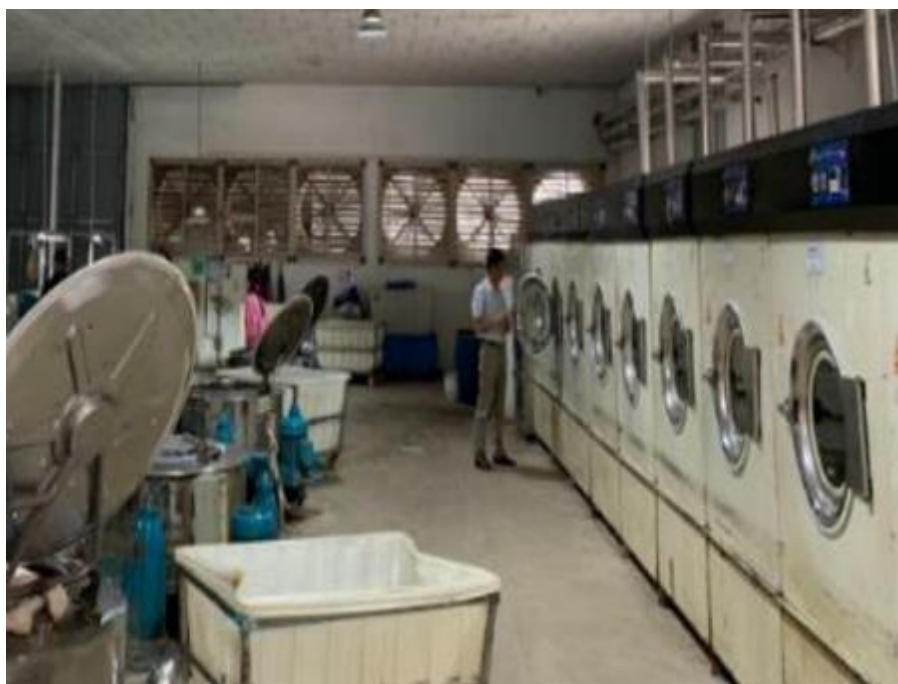
**Issues:** The factory installed air cooler fans near the washing machines, and all the washing machines are located near the exit doors. It was observed that relatively few employees work in this area, and the number of air-cooling fans is more than required, causing waste of energy.

Air cooler fans in washing area

**Intervention:** It is recommended to reduce the operation of the air cooler fans or turn off at least three numbers of air cooler fans.

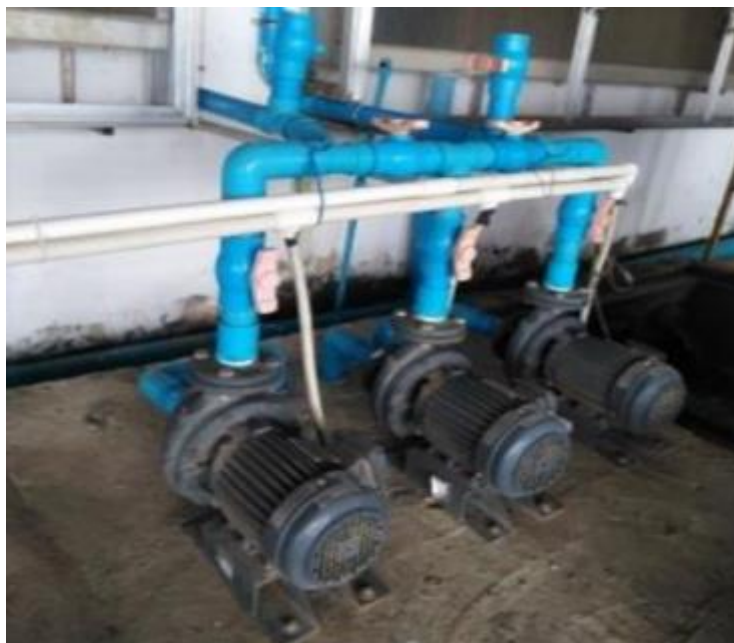
**Issues:** The factory has installed water pumps, but it was observed that some were running and others were on standby. At the same time, it was also observed that water pumps operate continuously despite having no control over their operation, and the valves in the water pipeline were fully open.

Water Pumps System

**Intervention:** It was recommended to install a relative humidity sensor controller for pumps to monitor conditions and adjust pump operation. This sensor sends feedback when humidity exceeds set levels, reducing energy consumption and running pumps until the desired conditions are met. And it is recommended to fully close the valve.

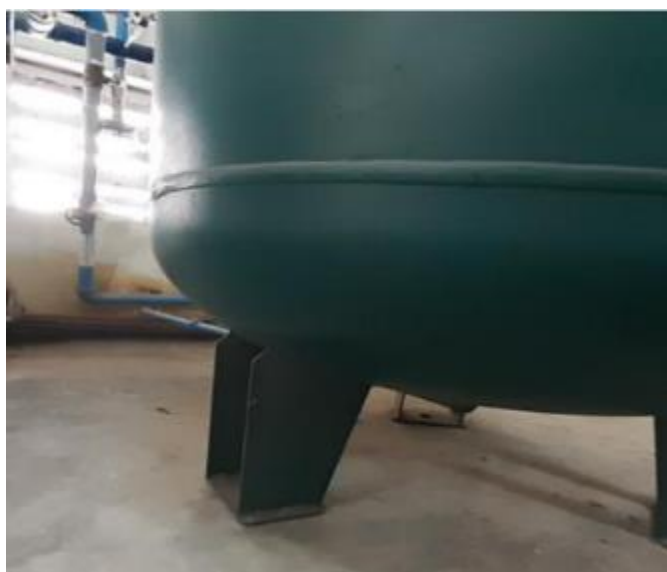
**Issues:** During the audit period, it was found that the air receiver tank installed for the air compressor did not have an automatic drain valve to remove condensate instantly. Currently, factory personnel drain the receiver tank manually prior to starting the compressors. However, after a few hours of compressor operation, the receiver tank will be filled with condensate. With condensate, the receiver tank's available volume decreases, resulting in frequent loading and increased power consumption. Also, the water from the receiver tank will carry forward to the dryer, increasing the dryer load.

Air receiver tank-sewing section

**Intervention:** It was recommended that the air receiver tank be equipped with an automatic drain valve. It instantly removes water condensate, reduces the air dryer, and lowers the energy consumption of the air compressor.

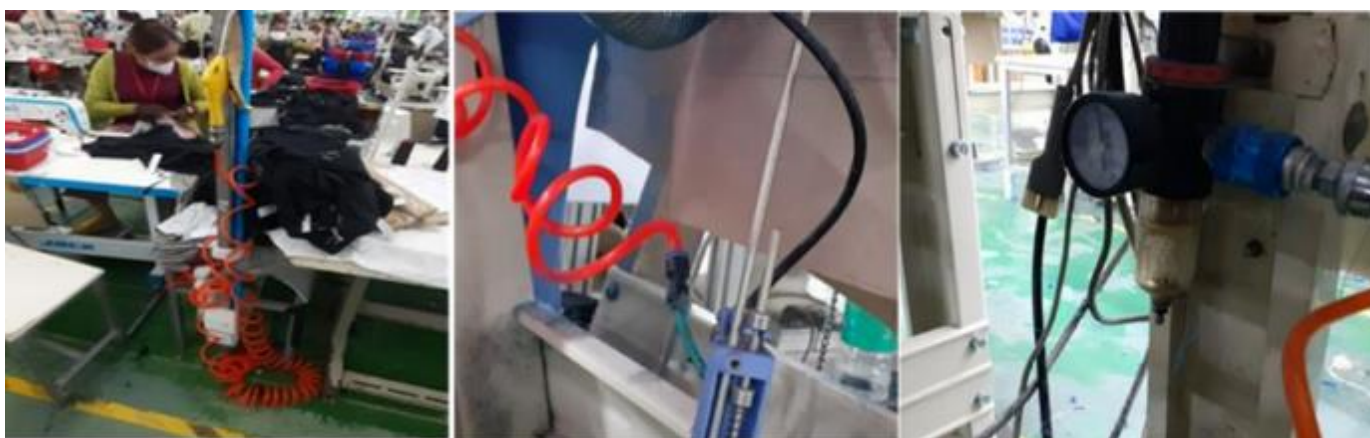
**Issues:** Compressed air is used in printing and fabric cleaning lines. The cleaning lines are equipped with an air blow gun, and it was observed that there was increased leakage at pipe joints, valves, and other locations. The majority of flexible lines are incapable of withstanding high pressures, and the set pressures on sewing machines were discovered to operate at a higher pressure than needed. Another problem observed is that the increased air pressure requirements of other equipment such as heat transfer and cutting machines, as well as the high air leakage in the compressed air line, lead to the tapping lines being under extremely high pressure.

Compressed air tapping for sewing machines and cleaning lines

**Intervention:** To cut down on air consumption, it is recommended to install a pressure regulator and set it to the needed level for the sewing lines and the cleaning lines. And reduce the pressure setting to unload and load as needed.

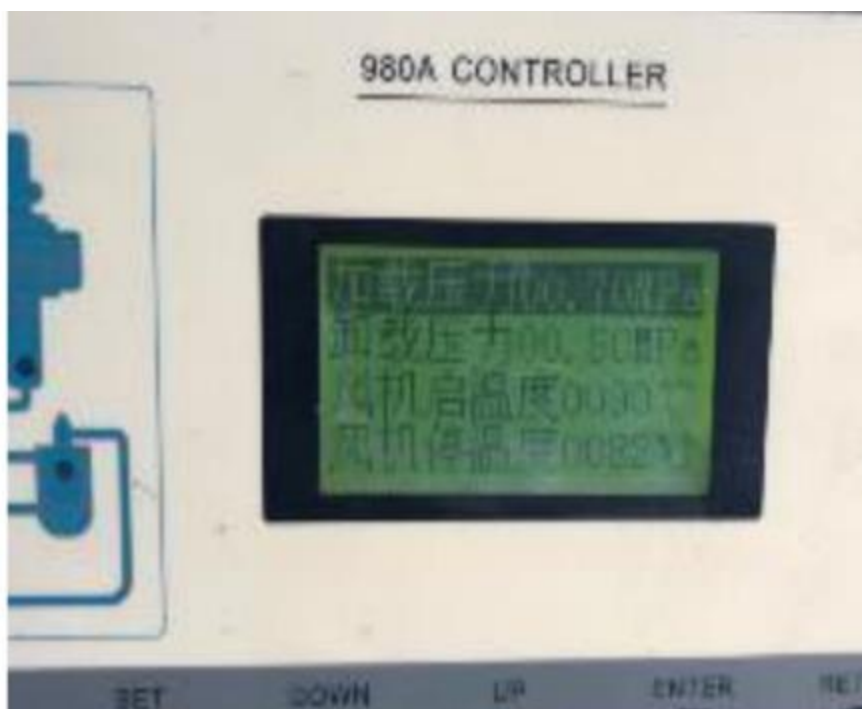
Present pressure setting

**Intervention:** So, it is suggested to optimize the pressure setting as needed by compressors for cut-off and cut-in.

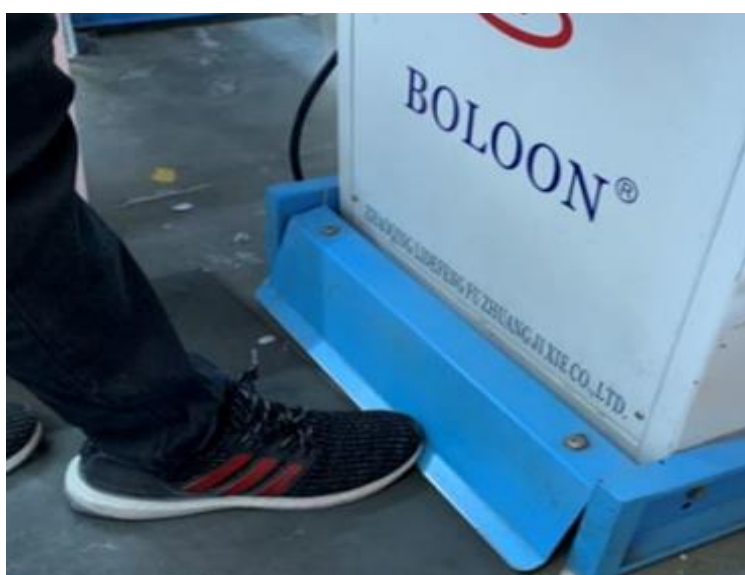
Foot operating switch for ironing table section blower

**Intervention:** To prevent idle suction blowers, foot-operated switches or optical position sensors should be installed on ironing tables. The sensor monitors the ironing box's position, activating the suction blower if it's moved. And also, it was recommended to install a proximity sensor with a time delay for the reverse fan.

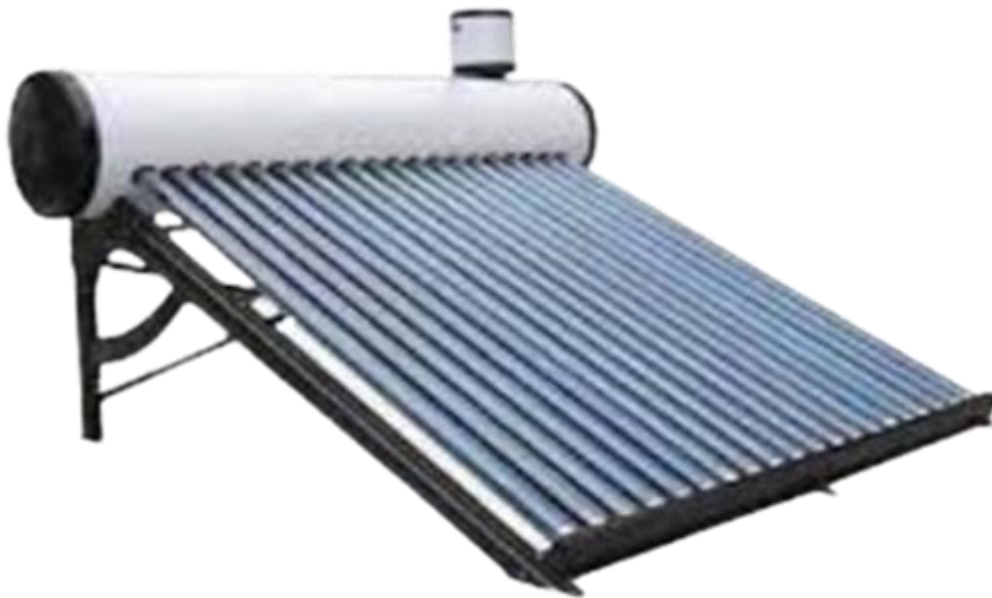
#### Solar Water Heater

**Intervention:** The recommendation is to install a solar water heater and provide hot water to rooms for baths. A solar hot water tank can be integrated with a thermostat and backup electrical heaters for emergencies.
